WOOD DESTROYING PESTS AND ORGANISM INSPECTION REPORT

Building No. 675	Street Sharon Park Drive #219	City Menlo Park	ZIP 94025	Date of Inspection 1/31/2008	Number of Pages Page 1 of 4
----------------------------	---	---------------------------	---------------------	--	---------------------------------------

General Description: One story, wood framed condominium. Limited to the interior only.	Inspection Tag Posted Kitchen sink Other Tags Posted None Noted
---	--

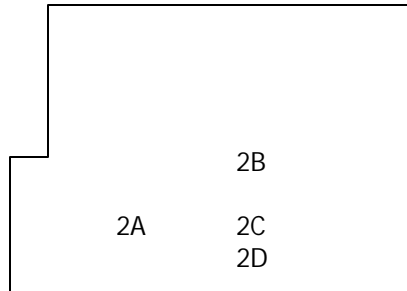
FRONT
Diagram Not To Scale

2A. FINDING: Water stains were noted beneath the kitchen sink. No evidence of any wood decay was noted at this time.

2B. FINDING: The toilet in the hall bathroom is loose or improperly mounted.

2C. FINDING: There is evidence of water leakage around the master bathroom glass stall shower enclosure.

2D. FINDING: There is a plumbing leak at the master bathroom sink drain.

RECOMMENDATION: Seal the area between the sink and counter top to prevent future moisture intrusion.
***** (SECTION 2 ITEM) *****

RECOMMENDATION: Reinstall the toilet correctly using a new no-seep toilet seal. If, upon removing the toilet, a cracked toilet or improper hercules ring is revealed, there would be additional charges for a new toilet or repairs to the hercules ring.
***** (SECTION 2 ITEM) *****

RECOMMENDATION: Reseal this enclosure in the most practical way. With this type of enclosure, we cannot guarantee to completely stop the leakage, only to control it. It will be the owners responsibility to maintain this enclosure in a waterproof condition.
***** (SECTION 2 ITEM) *****

RECOMMENDATION: Reseal or repair this leak in the most practical way.
***** (SECTION 2 ITEM) *****
